HYGEIA INC.

REPORT AND RECOMMENDATIONS OF THE SURVEY FOR ASBESTOS AND PCB-CONTAINING MATERIALS AT THE PROPOSED COMMONWEALTH CENTER DEVELOPMENT SITE, WASHINGTON STREET, BOSTON, MASSACHUSETTS

VOLUME ONE  
SURVEY REPORT OF  
ASBESTOS AND PCB-CONTAINING MATERIALS  
COMMONWEALTH CENTER DEVELOPMENT SITE  
BOSTON, MASSACHUSETTS

May 31, 1989

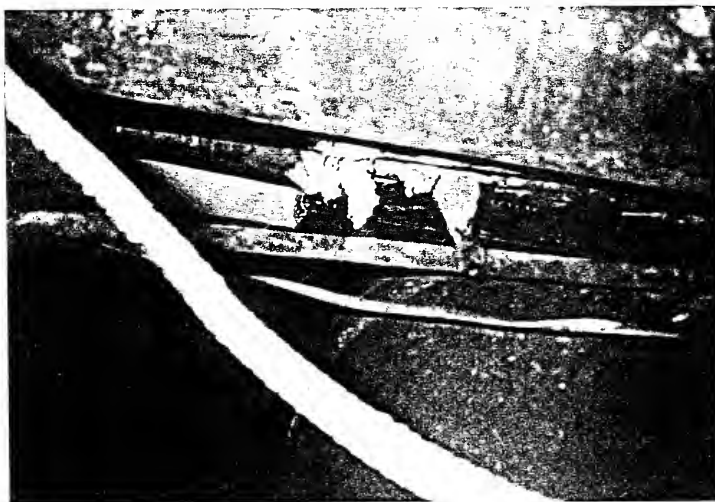
#4: Significantly damaged pipe insulation - tunnel from St. Francis House to Boiler Room

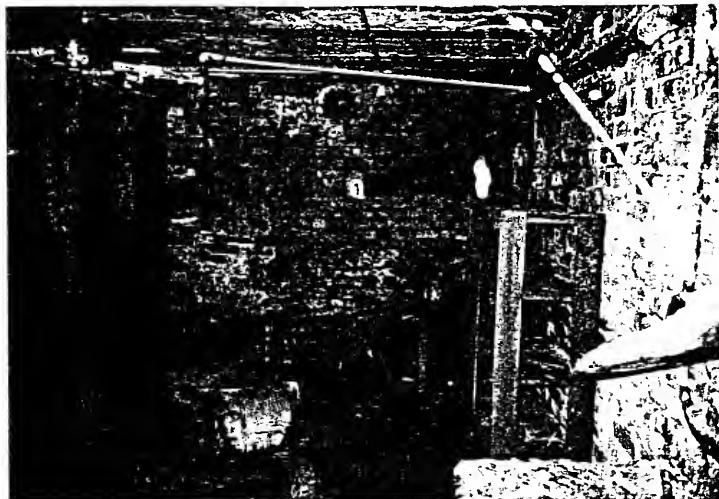
#5: Contaminated debris in storage room by entrance to Boiler Room

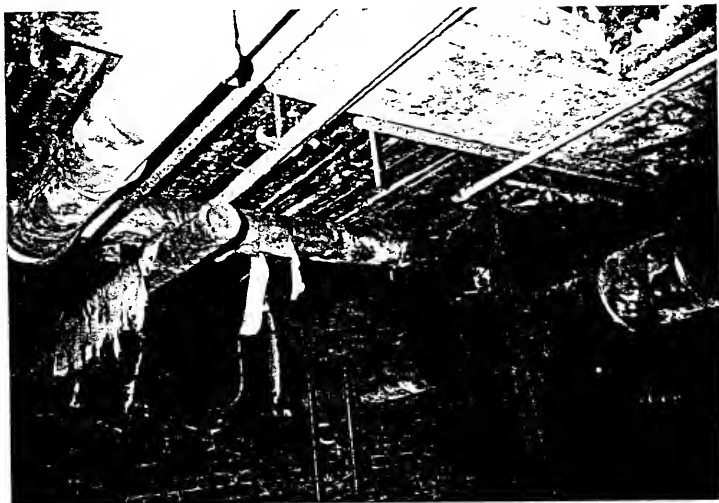
#7: Significantly damaged pipe insulation - Boiler Room

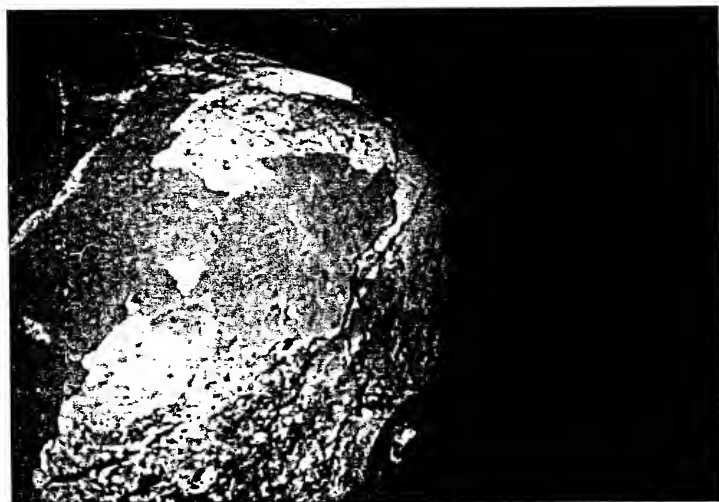
#8: Significantly damaged tank insulation - Boiler Room

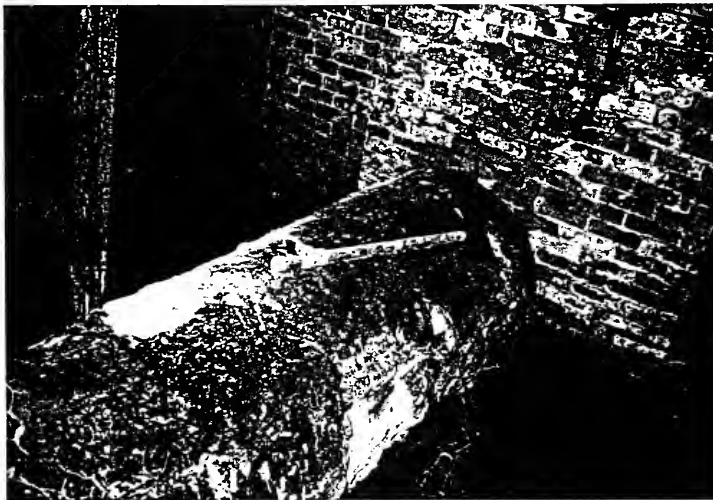
#9: Significantly damaged tank insulation - Boiler Room

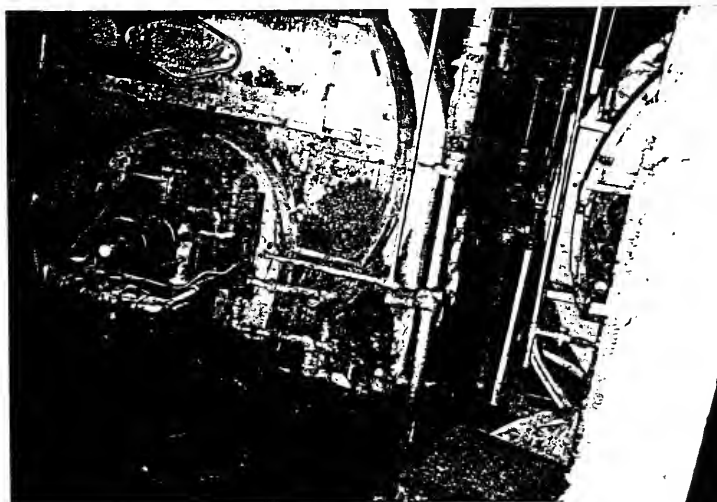
#10: Boilers with significantly damaged insulation - Boiler Room

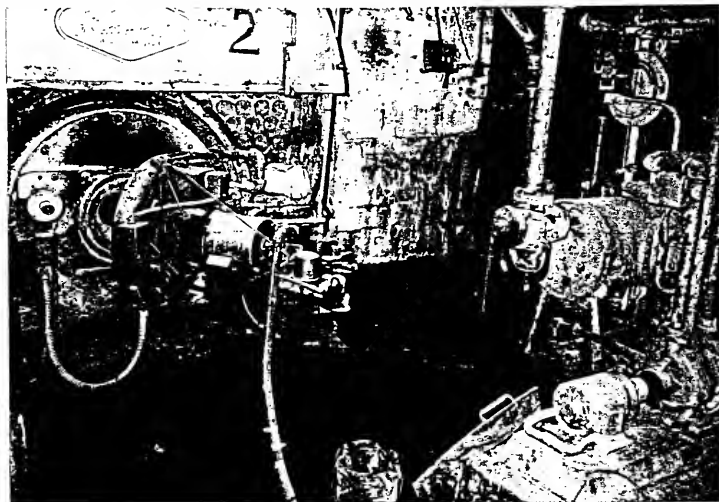
#11: Boilers with significantly damaged insulation - Boiler Room

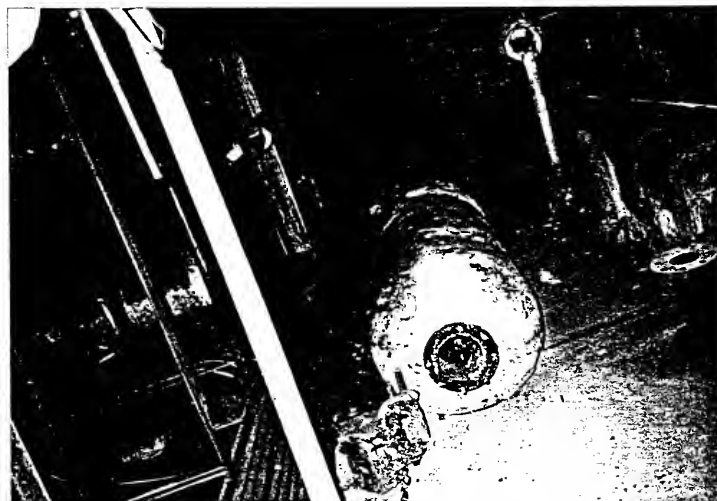
#12: Significantly damaged tank insulation - steam tunnel to right of Boiler Room

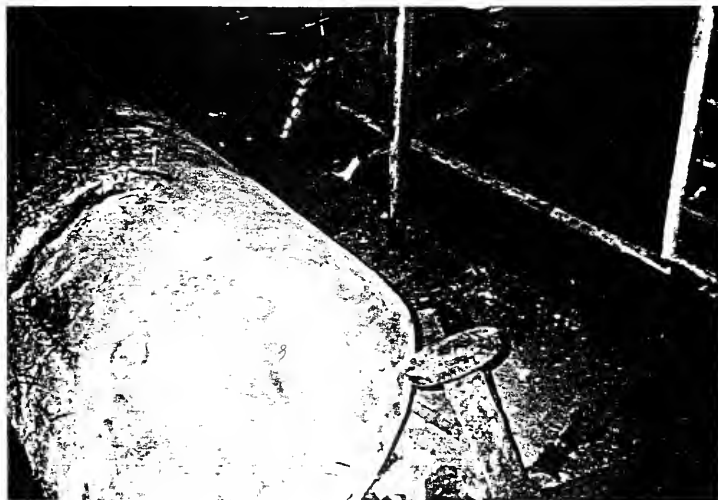
#13: Significantly damaged tank insulation - steam tunnel to right of Boiler Room

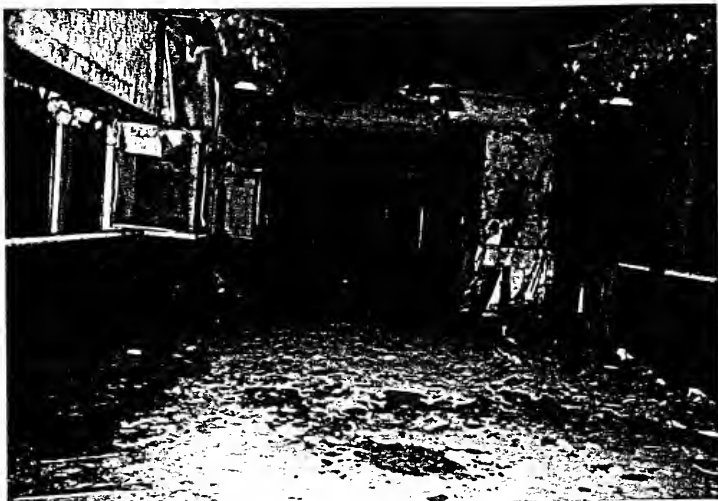
#1: View of first floor lounge showing contaminated ceiling debris on floor

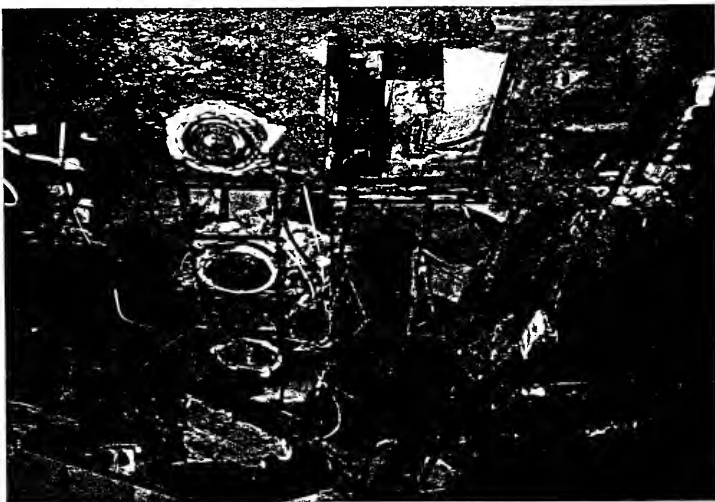
#3: View of water damaged duct insulation and ceiling - first floor lounge

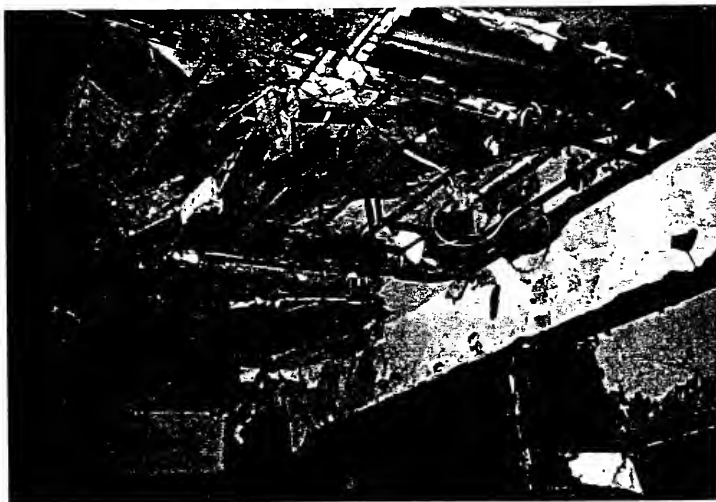
#4: View of water damaged duct insulation and ceiling - first floor lounge

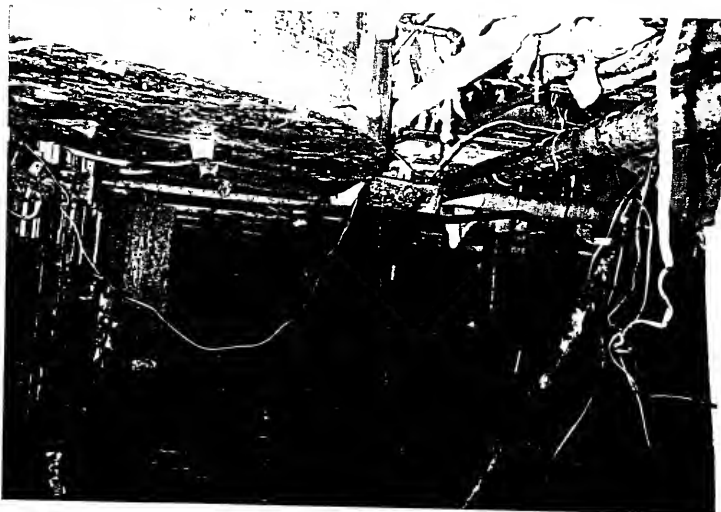
#7: View of back section of basement under first floor lounge

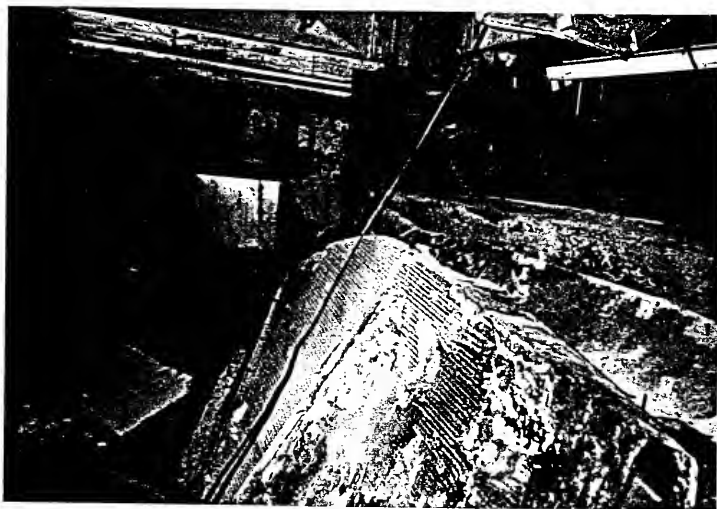
#9: Contaminated debris and demolished insulated ductwork on floor - basement of first floor lounge

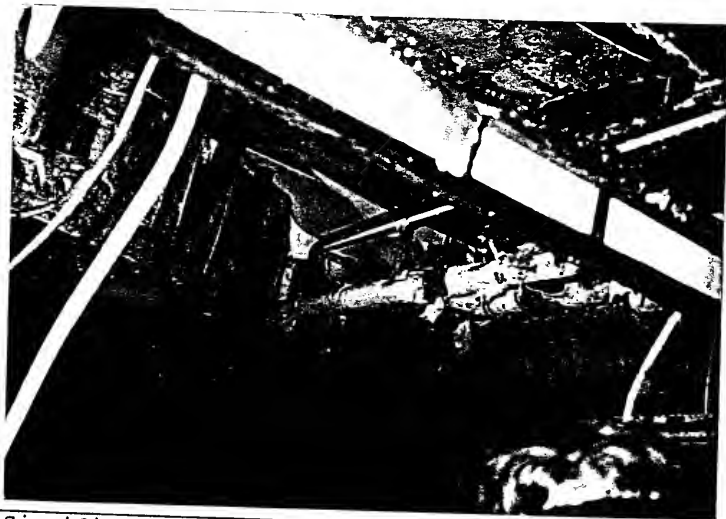
#14: Significantly damaged pipe and duct insulation - basement of first floor lounge

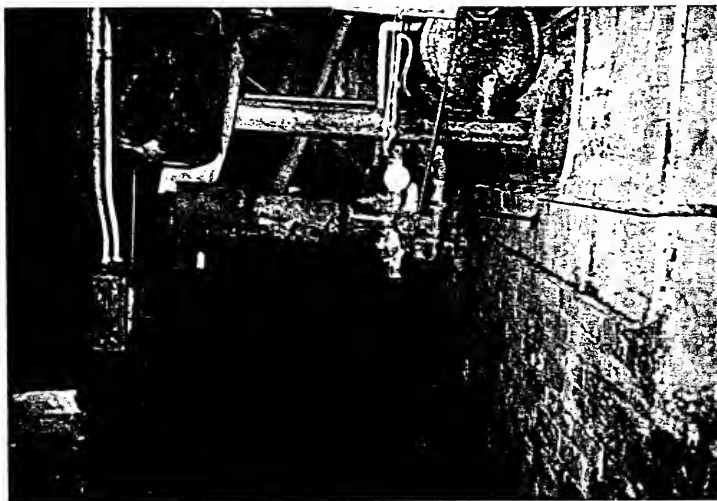
#17: View of Boiler Room showing tank and flooded area - sub-basement

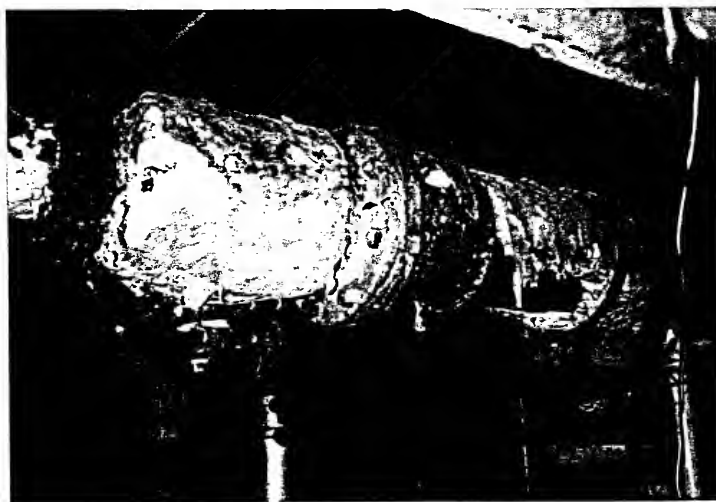
#18: Significantly damaged pipe insulation - sub-basement

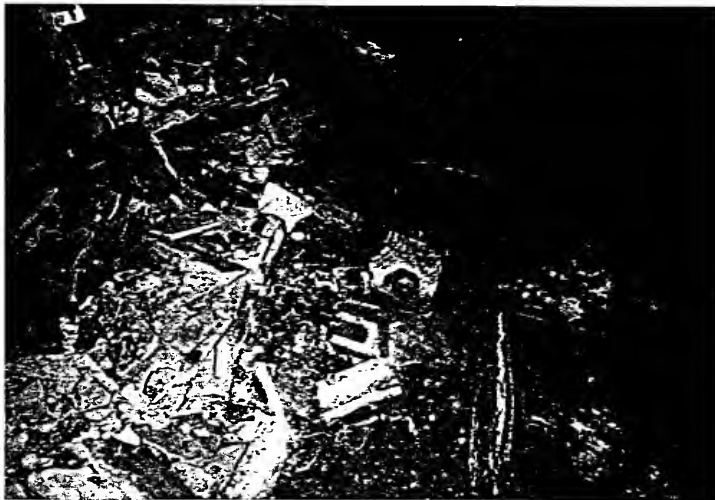
#19: Collapsed wall and contaminated debris - sub-basement

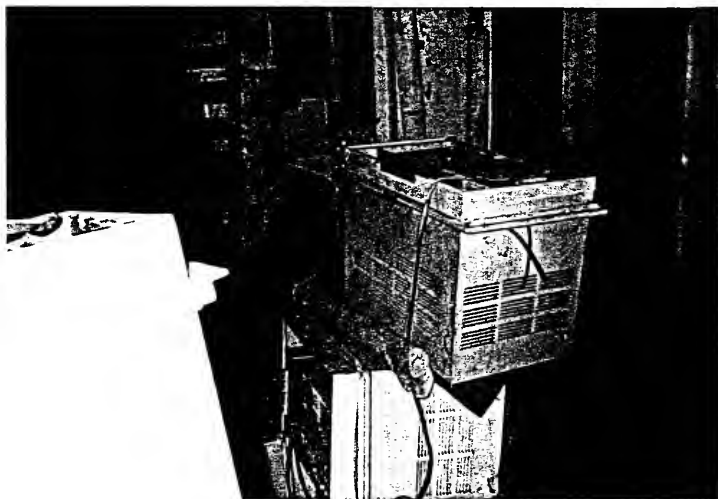
#22: Air conditioners, pipe insulation, and contaminated debris -  
basement

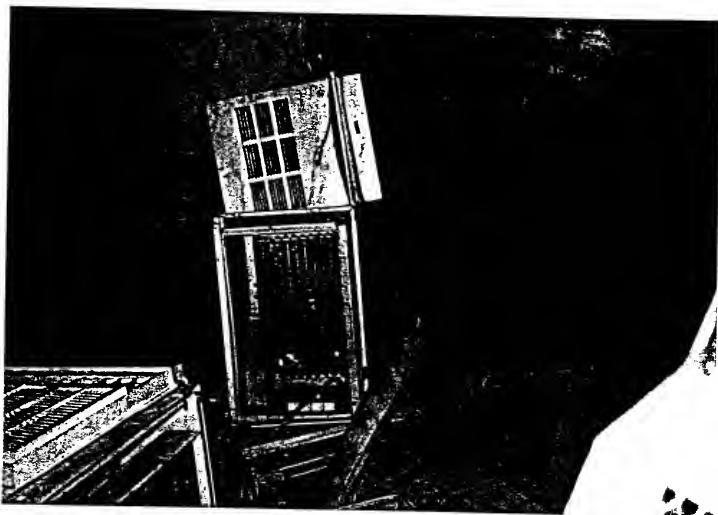
#23: Air conditioners, pipe insulation and contaminated debris -  
basement

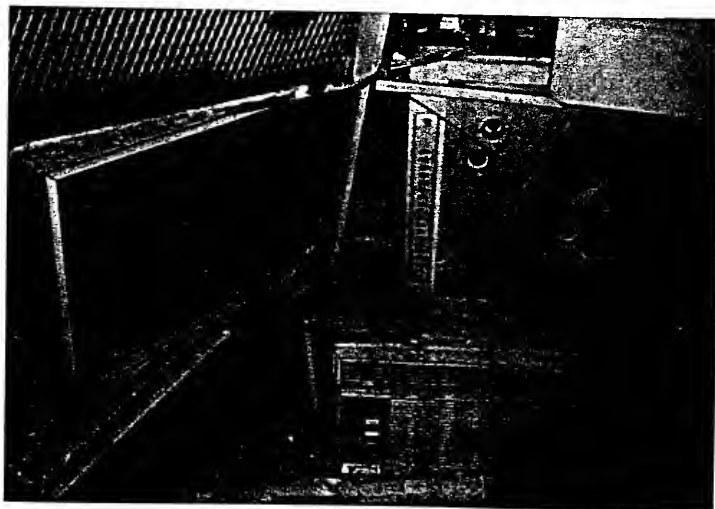
#24: Air conditioners, pipe insulation and contaminated debris -  
basement

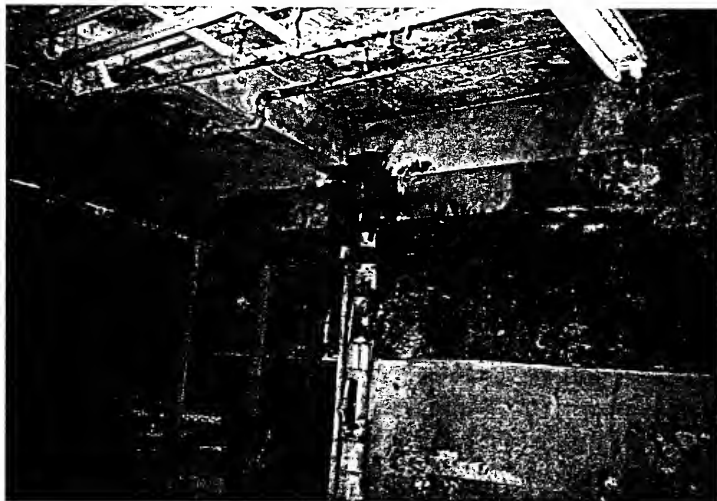
#31: Significantly damaged pipe insulation - basement

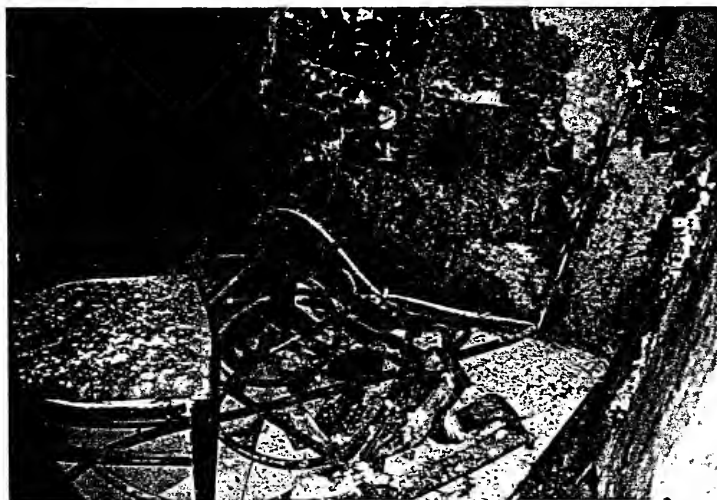
#32: Contaminated debris - basement

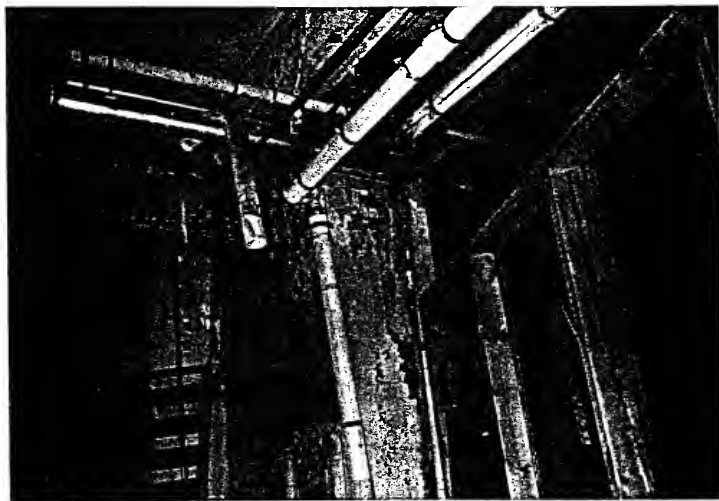
#39: Significantly damaged pipe insulation - basement

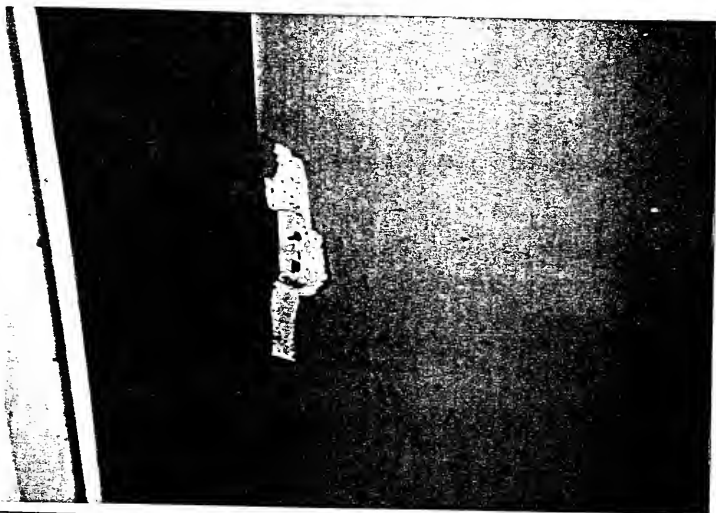
#41: Damaged fire door - second floor

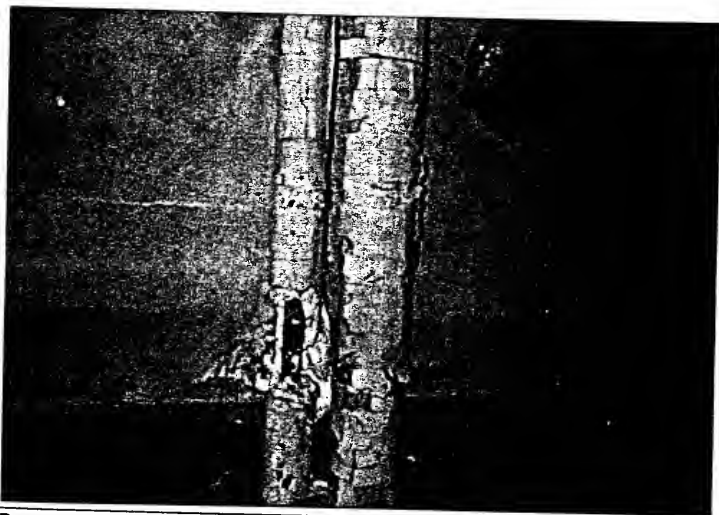
#42: Damaged pipe insulation - back section, third floor

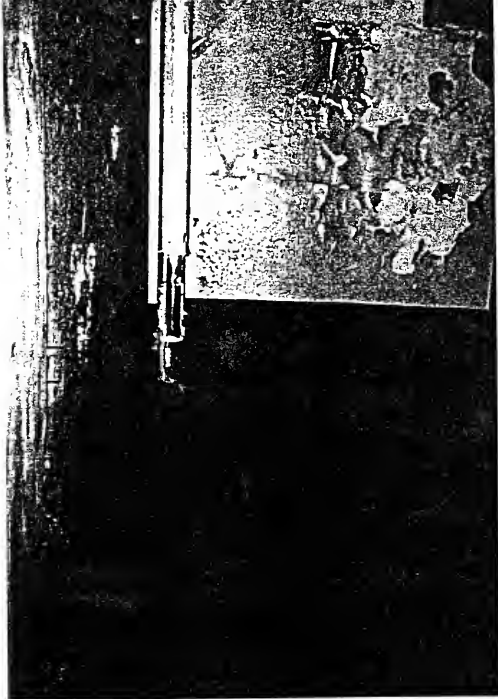
#43: Damaged pipe insulation - back section, third floor
